# HIGHWAY RESEARCH REPORT

## THE SAN FERNANDO EARTHQUAKE

### SOILS AND GEOLOGIC INVESTIGATIONS IN RELATION TO HIGHWAY DAMAGE

**NO. M & R 632119**

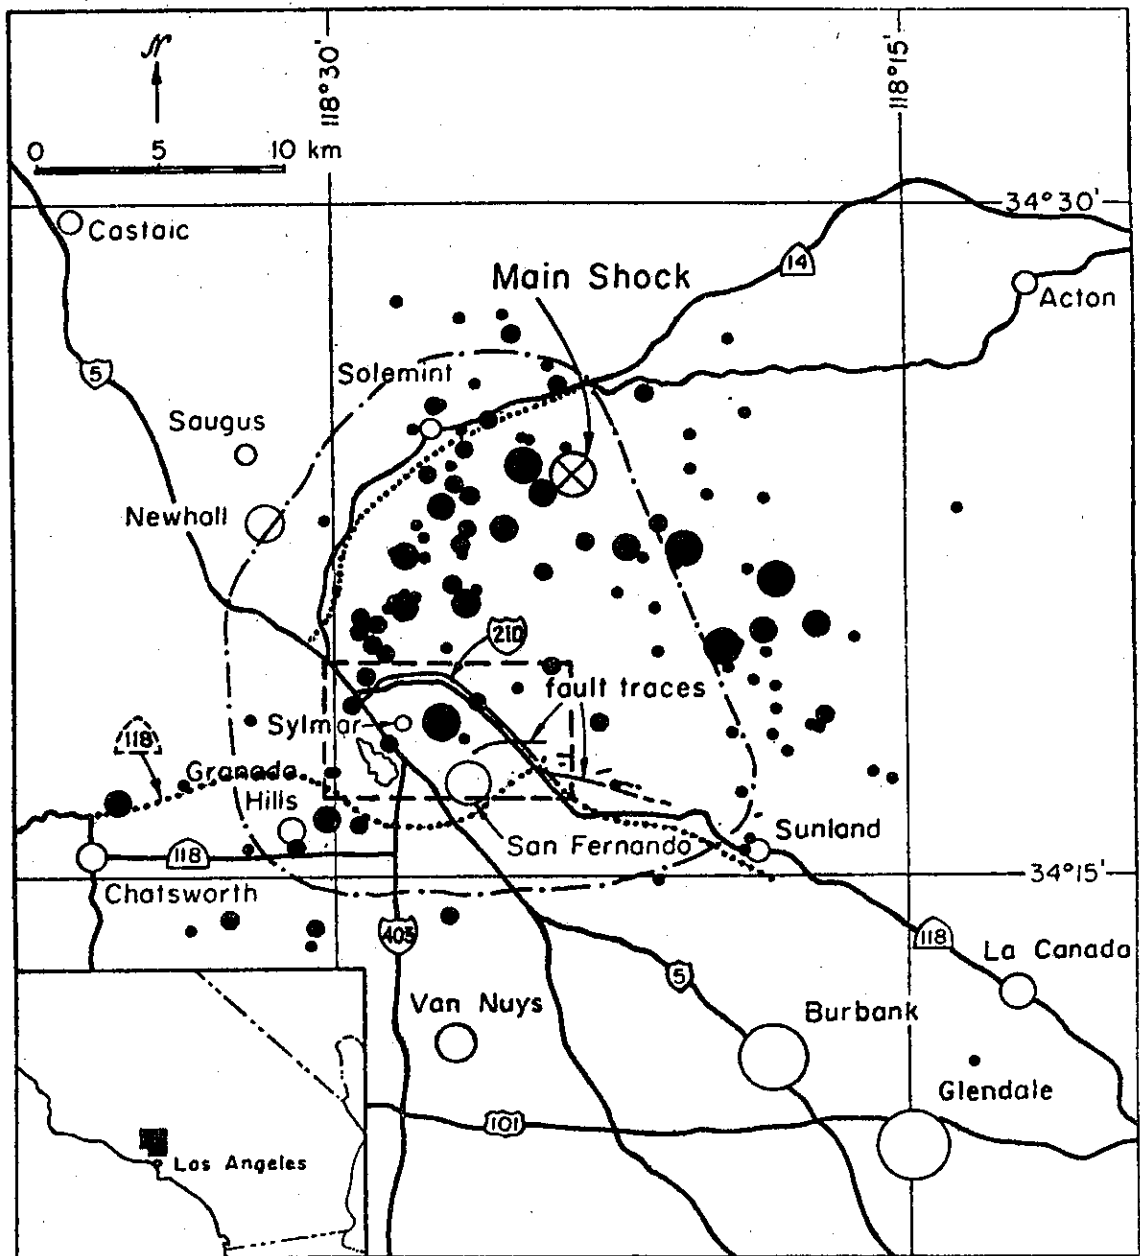
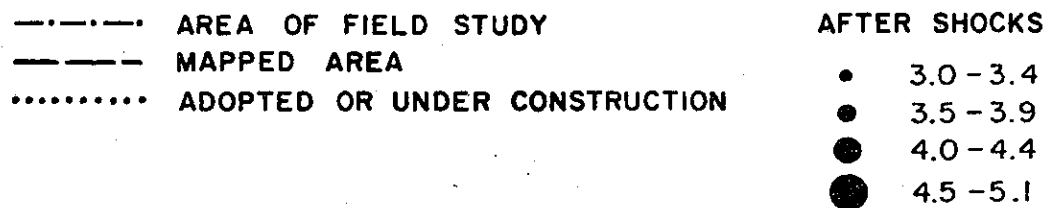
**Figure 1 GENERAL AREA OF FIELD STUDY,  
MAPPED AREA, AND AFTERSHOCKS**

Continuing studies of the aftershocks by Cal Tech seismologists are contributing to the overall picture of tectonic movement. These shocks, with an average focal depth of about four miles (maximum eight miles), have been divided into the eastern group, the epicentral group, and the Chatsworth group (Figure 1). According to Hanks, et al, (3) the focal depths of the eastern group are fairly shallow and are above the thrust plane as defined by the epicentral group (Figure 2b). Depths of the Chatsworth group, on the other hand, are deeper than the thrust plane. Based partly on this information Whitcomb (7) has suggested a model to describe the overall movement.

The area being studied is shown in Figure 1 and consists of the northern portion of the San Fernando Valley and the Newhall-Solemint Junction area northeast of and separated from the San Fernando Valley by the San Gabriel Mountains. This is the area in which damage to freeways, private dwellings, and other structures was concentrated, although scattered damage (generally not involving roads) did occur in other areas of metropolitan Los Angeles.

The mapped area is shown in Figure 1. Detailed mapping is shown in Plate 1 and will be referred to later as the "map area." Practically all faulting and other ground breakage that affected major highways occurred in the map area.

Six major roads (five freeways and one State highway) traverse the earthquake affected area as shown in Figure 1. The most important single road is Interstate Route 5 (Golden State Freeway) which is the main north-south artery for traffic entering and leaving the northern metropolitan Los Angeles area. Interstate Route 405 (San Diego Freeway) junctions with Route 5 in the northern San Fernando Valley to provide a more direct north-south route through the metropolitan area westerly of downtown Los Angeles. About 2.2 miles north of the Route 5/405 junction, Route 5 interchanges with Interstate Route 210 (Foothill Freeway) at the southern base of the San Gabriel Mountains. Route 210 is

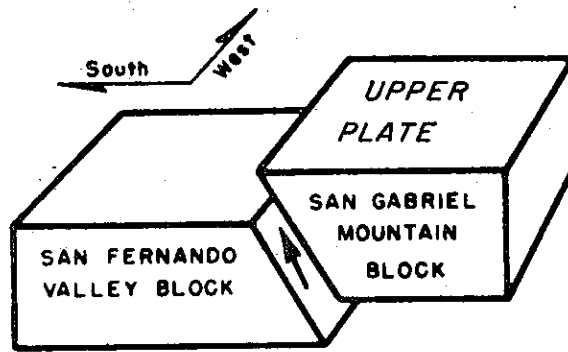
Regional tectonic movement consisted of an upper plate (Figure 2a), more or less delineated by the inverted "U" shape formed by the aftershock locations shown in Figure 1, that moved to the south and west along a thrust fault plane dipping about 45° to the

(a) BLOCK DIAGRAM OF  
FAULT MOVEMENT
